Info@mccuaig.net www.mccuaig.net**Building Envelope Restoration****CERTIFICATION OF COMPLETION ***PROJECT NUMBER: B10801PROJECT NAME: 1820 & 1880 East Kent Avenue South, Vancouver

**RE: Building Envelope Review at Pilot House - 1820 and 1880 East Kent Avenue South,
Vancouver, BC**

This report documents the follow-up building envelope review for the non-remediated portions of Strata Plan LMS 2113, commonly referred to as Pilot House. Inspections, testing and analyses were completed on the sections buildings not repaired during the recent two remediation projects. An initial investigation report for the entire complex was produced by McCuaig and Associates Engineering Ltd. in June 2001, (McCuaig Reference 01187B10501.)

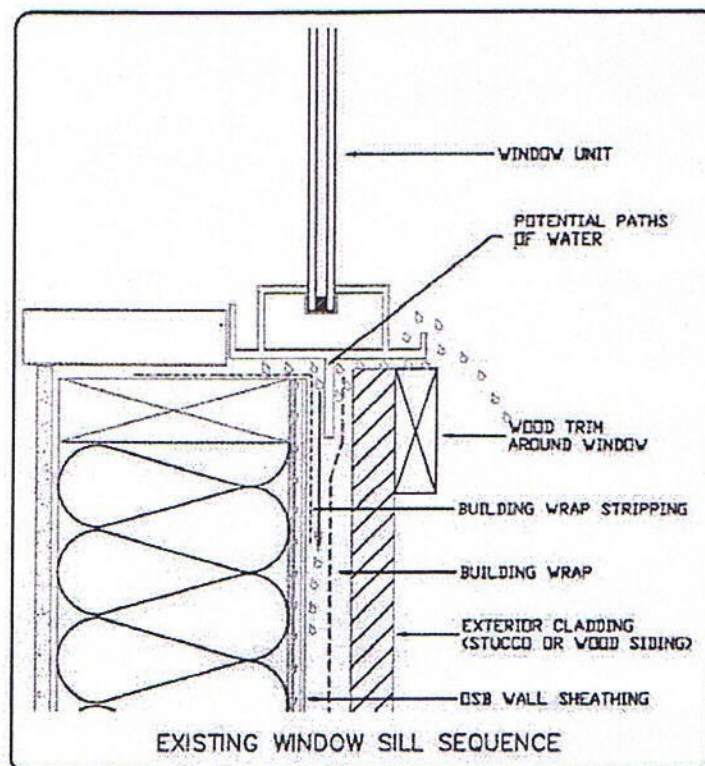
Figure 1. Original Construction Window Sill Sequence

Since the original windows are of questionable quality, and the sill details are negatively lapped with the building wrap. Leaks and damages will likely occur at some of the original window openings at some point in the future. However, no wood rot was noted during this survey. As such, the remaining original windows may provide several more years of service before requiring replacement. Regular monitoring should be completed to determine the optimal replacement time. It is difficult to estimate the remaining life of these windows; however, based on the results of our current investigation, the window should provide at least another five years of service.
