APPENDIX A: Exploratory Openings

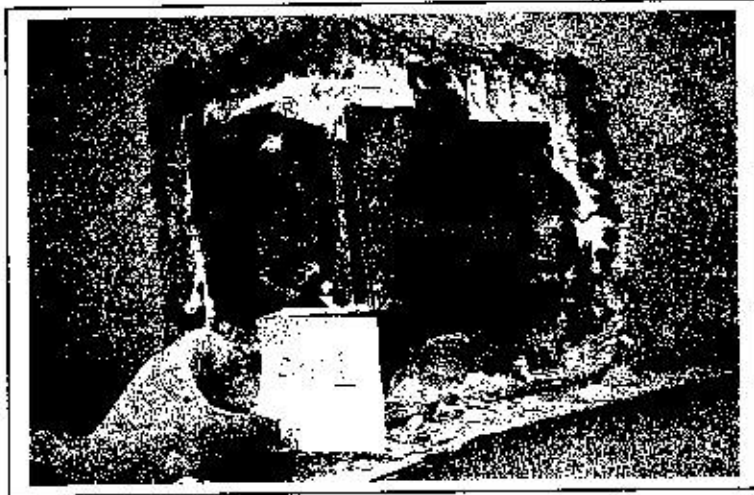
Photo A

Showing Exploratory Opening #1

- The metal lath and paper are in fair condition and do not show signs of staining; the plywood sheathing has undergone water ingress as is evidenced by the black staining and minor mold growth;
- The moisture content readings of the sheathing are 22%.
- The poorly sloped flashing in this area does not promote proper water drainage.

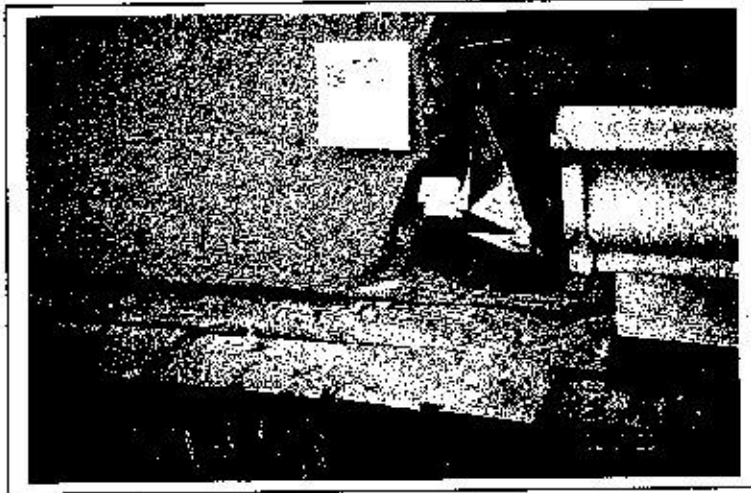
Photo B

Showing Exploratory Opening #2

- The metal lath and tyvek are in fair condition and do not show signs of staining; the plywood sheathing does not appear to have undergone water ingress;
- The moisture content readings of the sheathing are 20%.
- The efflorescence staining at the top of the masonry wall in this corner location shows that the water draining from the flashing is soaking into the brick and then evaporating at a later date. This flashing should extend over the top of the brick.

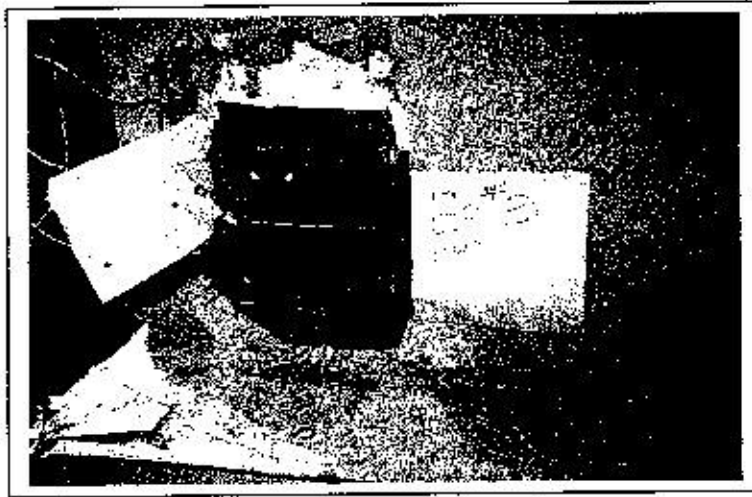
Photo C

Showing Exploratory Opening #3

- The metal lath and paper are in fair condition and do not show signs of staining; the plywood sheathing does not appear to have undergone water ingress;
- The moisture content readings of the sheathing are 20%,

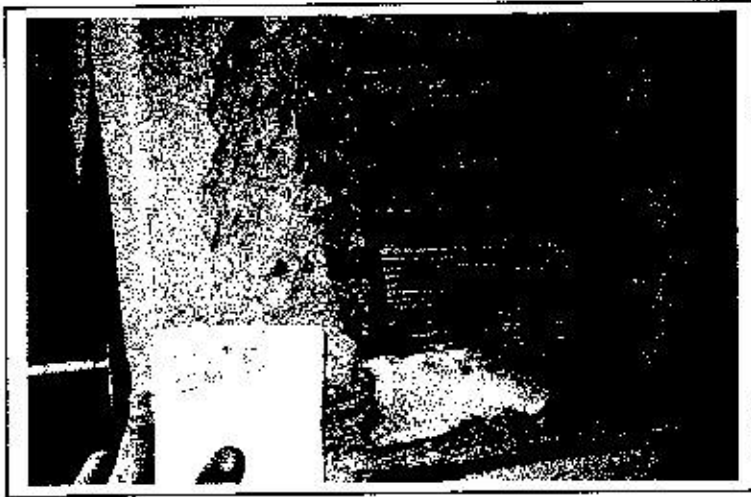
Photo E

Showing Exploratory Opening #5

- The beams have undergone some water ingress indicated by the water staining;
- The furring strips which were installed during the previous repair work are not pressure treated and have undergone mold staining and deterioration which indicates that the repairs did not properly address the water ingress;
- Moisture content readings of materials is 12%.

- We recommend ongoing monitoring of the glulam beams to ensure water ingress does not occur and that the current condition of the glulam beams does not deteriorate. This can be achieved by installing vented openings which will allow the beams to dry as well as these openings act as removable viewing holes to be able to examine the condition of the glulam beams on a regular basis.

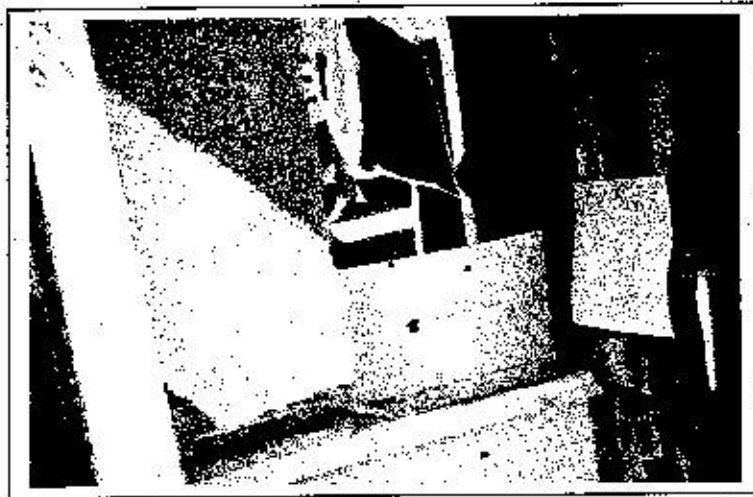
Photo F

Showing Exploratory Opening #6

- The wood trim board is in fair condition and does not show signs of staining or wetting, the nails used to fasten the board are also in fair condition;
- Moisture content readings of the board and sheathing are 20%.

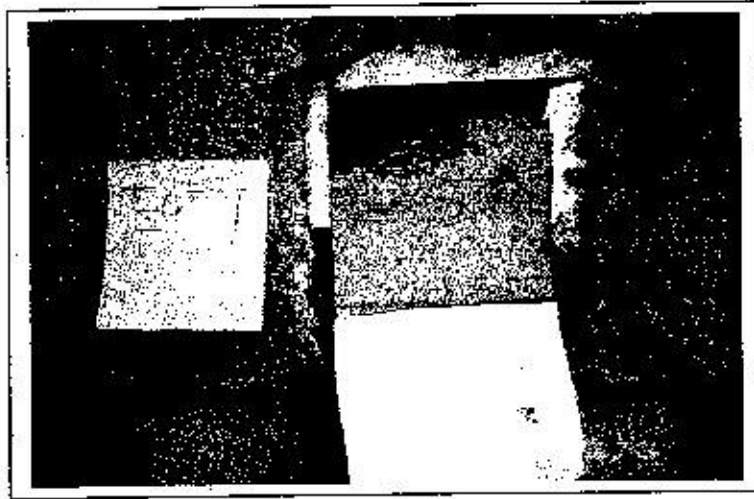
Photo G

Showing Exploratory Opening #7

- The metal lath and paper are in fair condition and do not show signs of staining; the plywood sheathing does not appear to have undergone water ingress;
- The moisture content readings of the sheathing are 10%;
- Despite the cracking of the stucco, the balcony column does not appear to have undergone any water ingress damage.

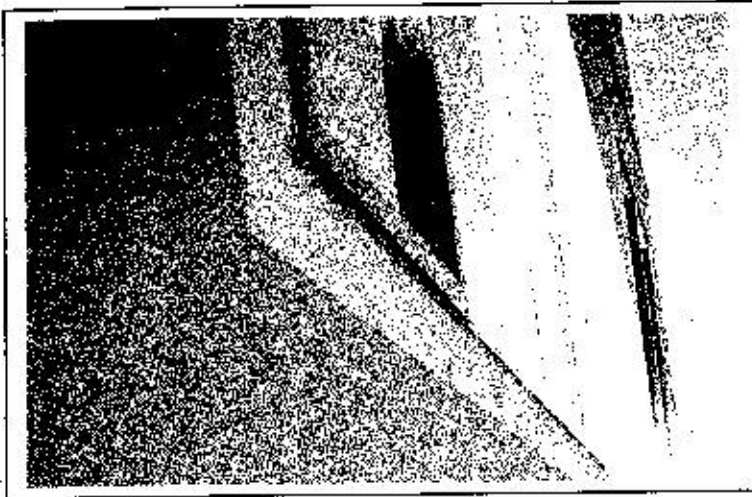
Photo H

Showing the location where Exploratory Opening #8 was performed.

- The metal lath and paper are in fair condition and do not show signs of staining; the plywood sheathing does not appear to have undergone any water ingress;
- The moisture content readings of the sheathing are 18%.
