## BC BUILDING SCIENCE

# **BUILDING ENVELOPE EVALUATION REPORT**

STRATA PLAN VAS 2876  
980 WEST 21ST AVENUE,  
VANCOUVER, B.C.

October 12, 2001

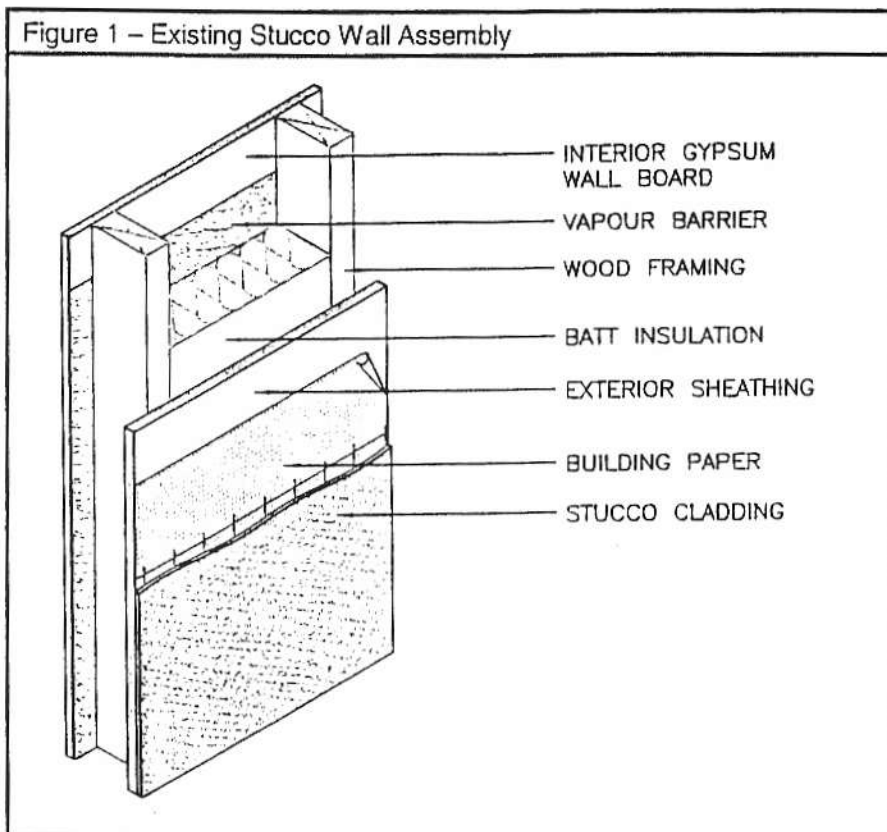
Figure 1 – Existing Stucco Wall Assembly

This wall assembly was confirmed by the investigative openings; however, at some of the previously repaired areas (T6 and T12), housewrap (Tyvek) was found in place of the building paper.

As previously discussed this wall assembly is described as "face sealed" system with a concealed moisture barrier. The combined air/vapour barrier utilizes the sealed polyethylene approach. This was typical for residential use at the time of construction. (For more information on this wall design refer to section 5.5.)

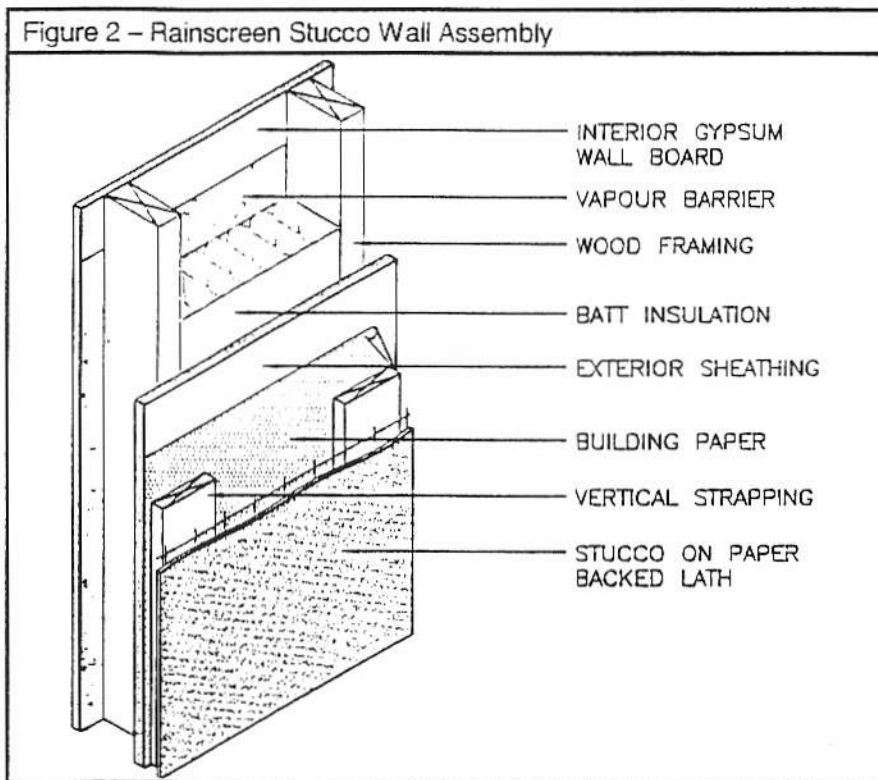
It is now the current practice to provide a "rainscreen" wall system (Figure 2) allowing drainage and drying behind the face of the cladding. The rainscreen system provides an air space behind the face of the exterior cladding with the installation of vertical strapping over the moisture barrier, which is properly shingled to provide positive drainage. This system improves both the venting and drainage potential of the wall assembly, thereby reducing the potential for water infiltration and corresponding structural damage. Rainscreen principles have been in use for many years and have proven their effectiveness with many types of claddings, specifically in masonry applications.

The rainscreen system, with the addition of cross-cavity flashings at floor levels and an upgrade in detailing around windows and other penetrations, is expected to provide enhanced long-term performance for most buildings. The City of Vancouver now requires all wall assemblies to utilise these rain-screen principles.
