**BC BUILDING SCIENCE & ENGINEERING LTD**

**Strata Plan VAS 2876 (02-0604)****April 16, 2003****FIELD REVIEW****880 West 21st Avenue, Vancouver, B.C.****Page 1 of 3****817/03**

**Existing Roof Framing:**

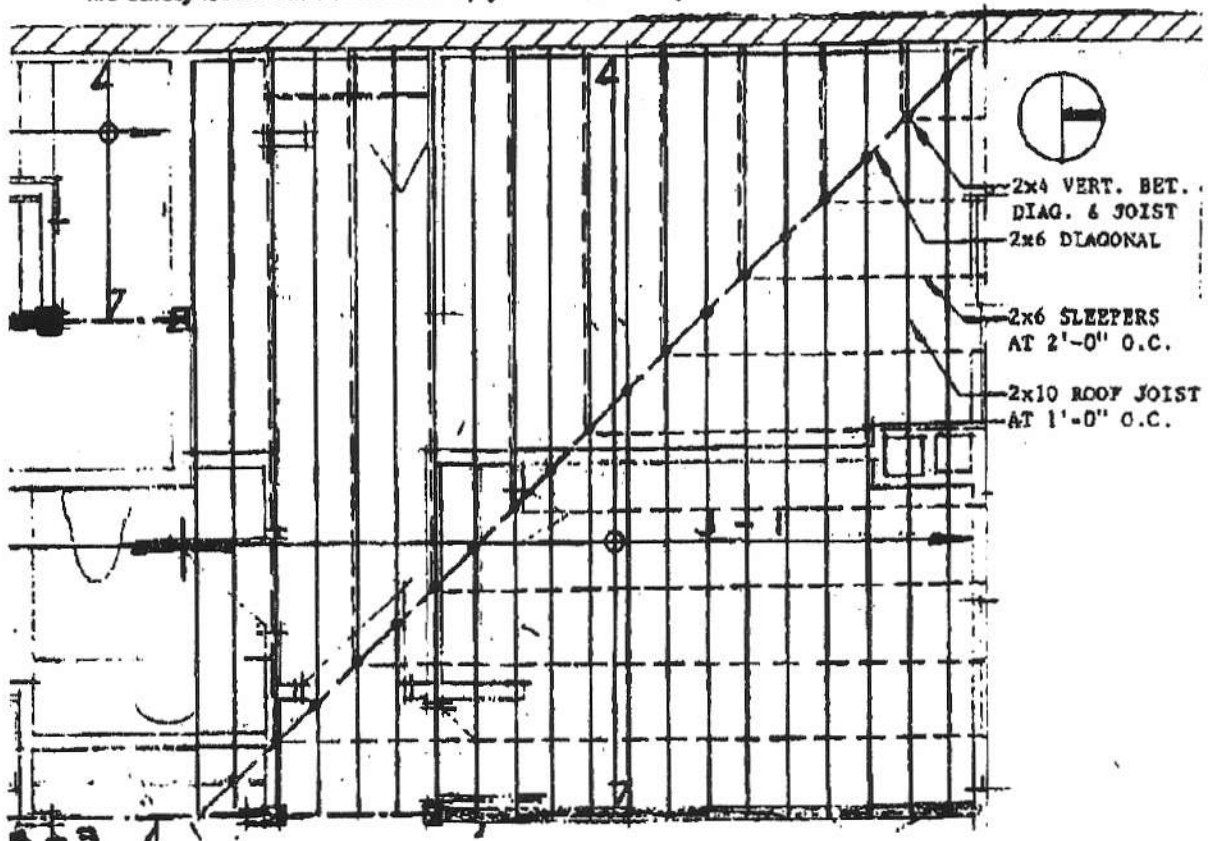
**PARTIAL ROOF FRAMING PLAN (NORTHWEST CORNER OF BUILDING)**

17.1 The contractor has removed a portion of the box joist from select areas at the roof edge to allow us to determine the framing of the roof in order to attach the new roof overhang. At the north edge of the roof (west end - near masonry wall) the 2x8 sleepers have been installed with a 3" space between the underside of the sleepers and the top of the 2x10 roof joists. A 2x8 diagonal sleeper (similar to a hip member of a roof) was installed from the northwest corner of the roof and spanned to the southeast. (See enclosed plan on page 2) On the southwest side of the diagonal, the 2x8 sleepers spanned east-west and on the northeast side of the diagonal, the 2x8 sleepers spanned north-south. Vertical pieces of 2x4 have been nailed to the side of the 2x10 roof joists to support the diagonal sleeper. No interior support of the other sleepers was installed. Therefore, the roof joists are not uniformly loaded by the roof sleepers as originally designed. Under building code snow loads:

- a. the 2x8 roof sleepers will deflect more than allowed by the code when the span exceeds 9'-0" and becomes overstressed at spans greater than 10'-9".
- b. the weight of the snow will only be transferred to the roof joists at the supports for the diagonal sleeper. This creates a concentrated load on the roof joist rather than the uniformly distributed load used in the original design. The roof joists will exceed the code allowable deflection limits and become overstressed under this condition.

2. The sleepers may collapse onto the roof joists which would likely result in membrane failure.
3. The sleepers may deflect, resulting in additional ponding of water and possibly localized fractures of the roof membrane.
4. The roof is not constructed to meet the current building code or the building code required at the time of construction. It is difficult to predict when or if this condition could result in a life safety issue. We do note that wood framing has additional capacity above the code limits due to variations in lumber strengths.

We recommend that additional plates be installed, perpendicular to the roof joists at 2'-0" o.c. (or under each sleeper) to fill in the space between the sleepers and roof joists. This work is necessary for two reasons:

- a. This will uniformly distribute the snow load along the entire span of the 2x10 roof joists as per the original structural design.
- b. The plates will provide lateral support for the top edge of the roof joists.

This work would necessitate the removal of the entire roof membrane system and plywood sheathing.
