## BC BUILDING SCIENCE

# **BUILDING ENVELOPE EVALUATION REPORT**

STRATA PLAN VAS 2876  
980 WEST 21ST AVENUE,  
VANCOUVER, B.C.

October 12, 2001

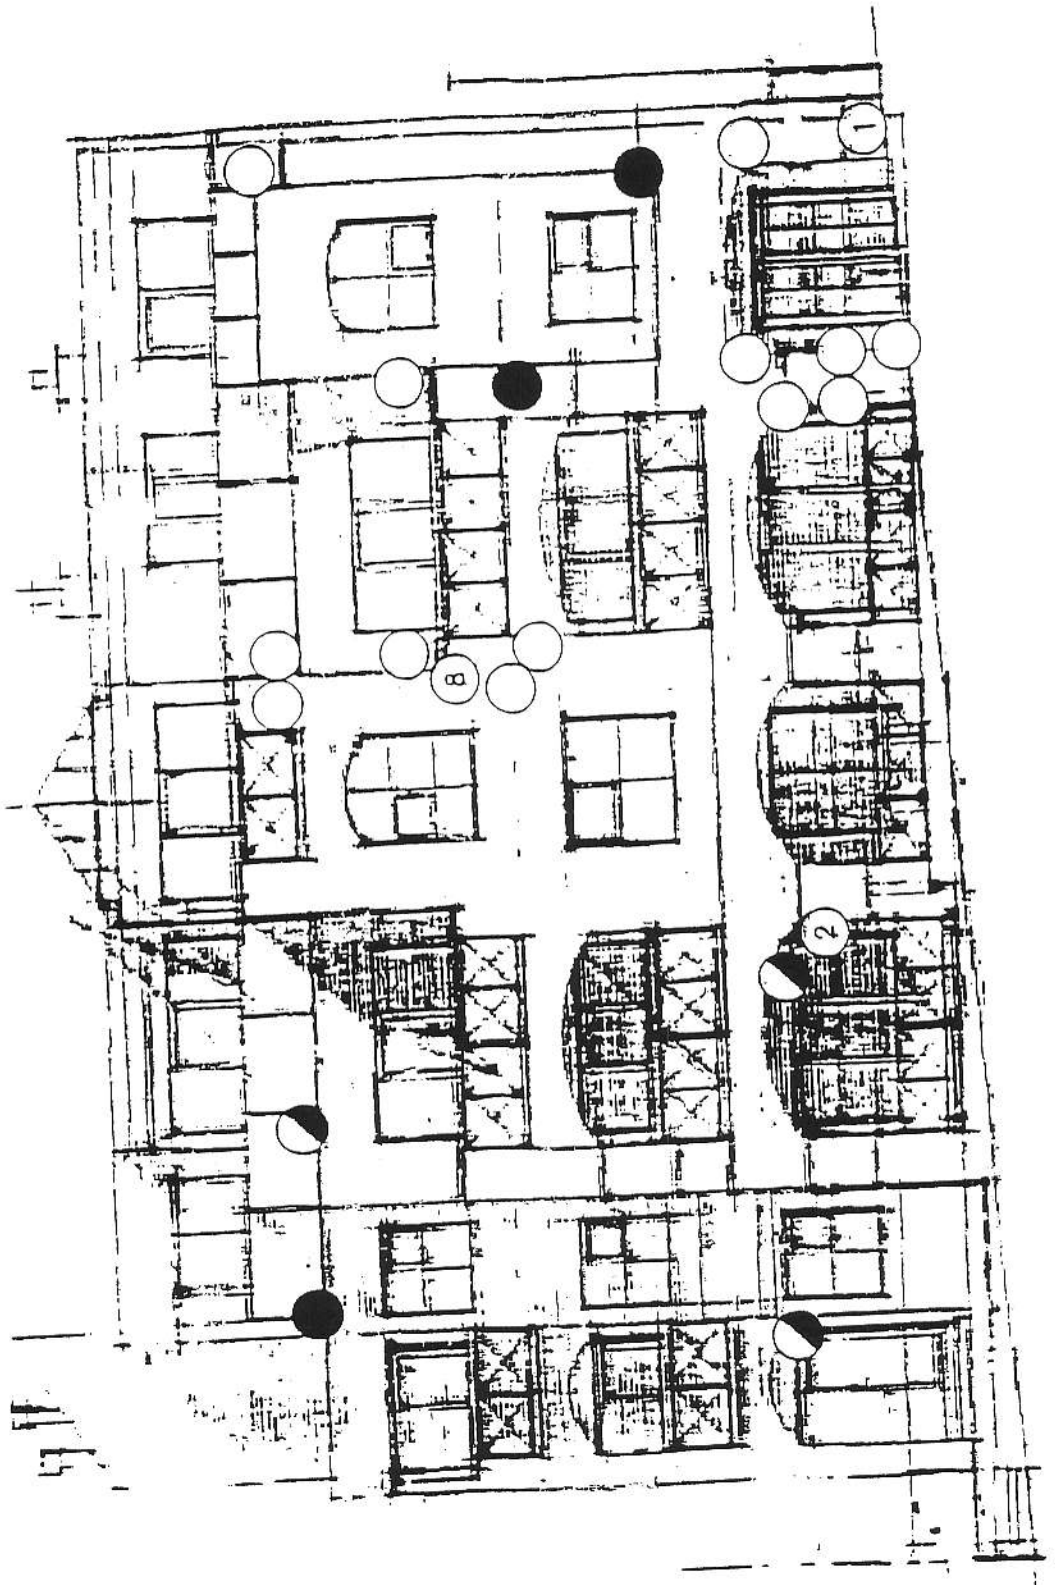
## NORTH ELEVATION

ID#	LOCATION	OBSERVATIONS
T1 (5)	North Elevation - Entry at base of west false build out	Removed stucco cladding and building paper; waterproofing more than 200mm up from slab; wall sheathing decayed, dry. Removed wall sheathing; framing decayed, dry.
T2 (6)	North Elevation - Unit 204 balcony soffit	Removed gypsum soffit; underside of floor sheathing stained with signs of mould growth; joists stained at ends, otherwise dry.
T3 (7,8)	East Elevation – Unit 103 base of wall at north corner	Removed stucco cladding and building paper; stucco thickness over 19mm; building paper lapped over waterproofing; waterproofing in poor condition. Removed wall sheathing; sill plate and other framing decayed.
T4 (9)	East Elevation – Unit 203 balcony soffit at vents	Removed perforated metal soffit; build up of lint and insects; vent sleeve not attached to duct; vents plugged causing back-up of moist air; stains on face of rim joist; rim joist at 20-25% MC; joists dry.

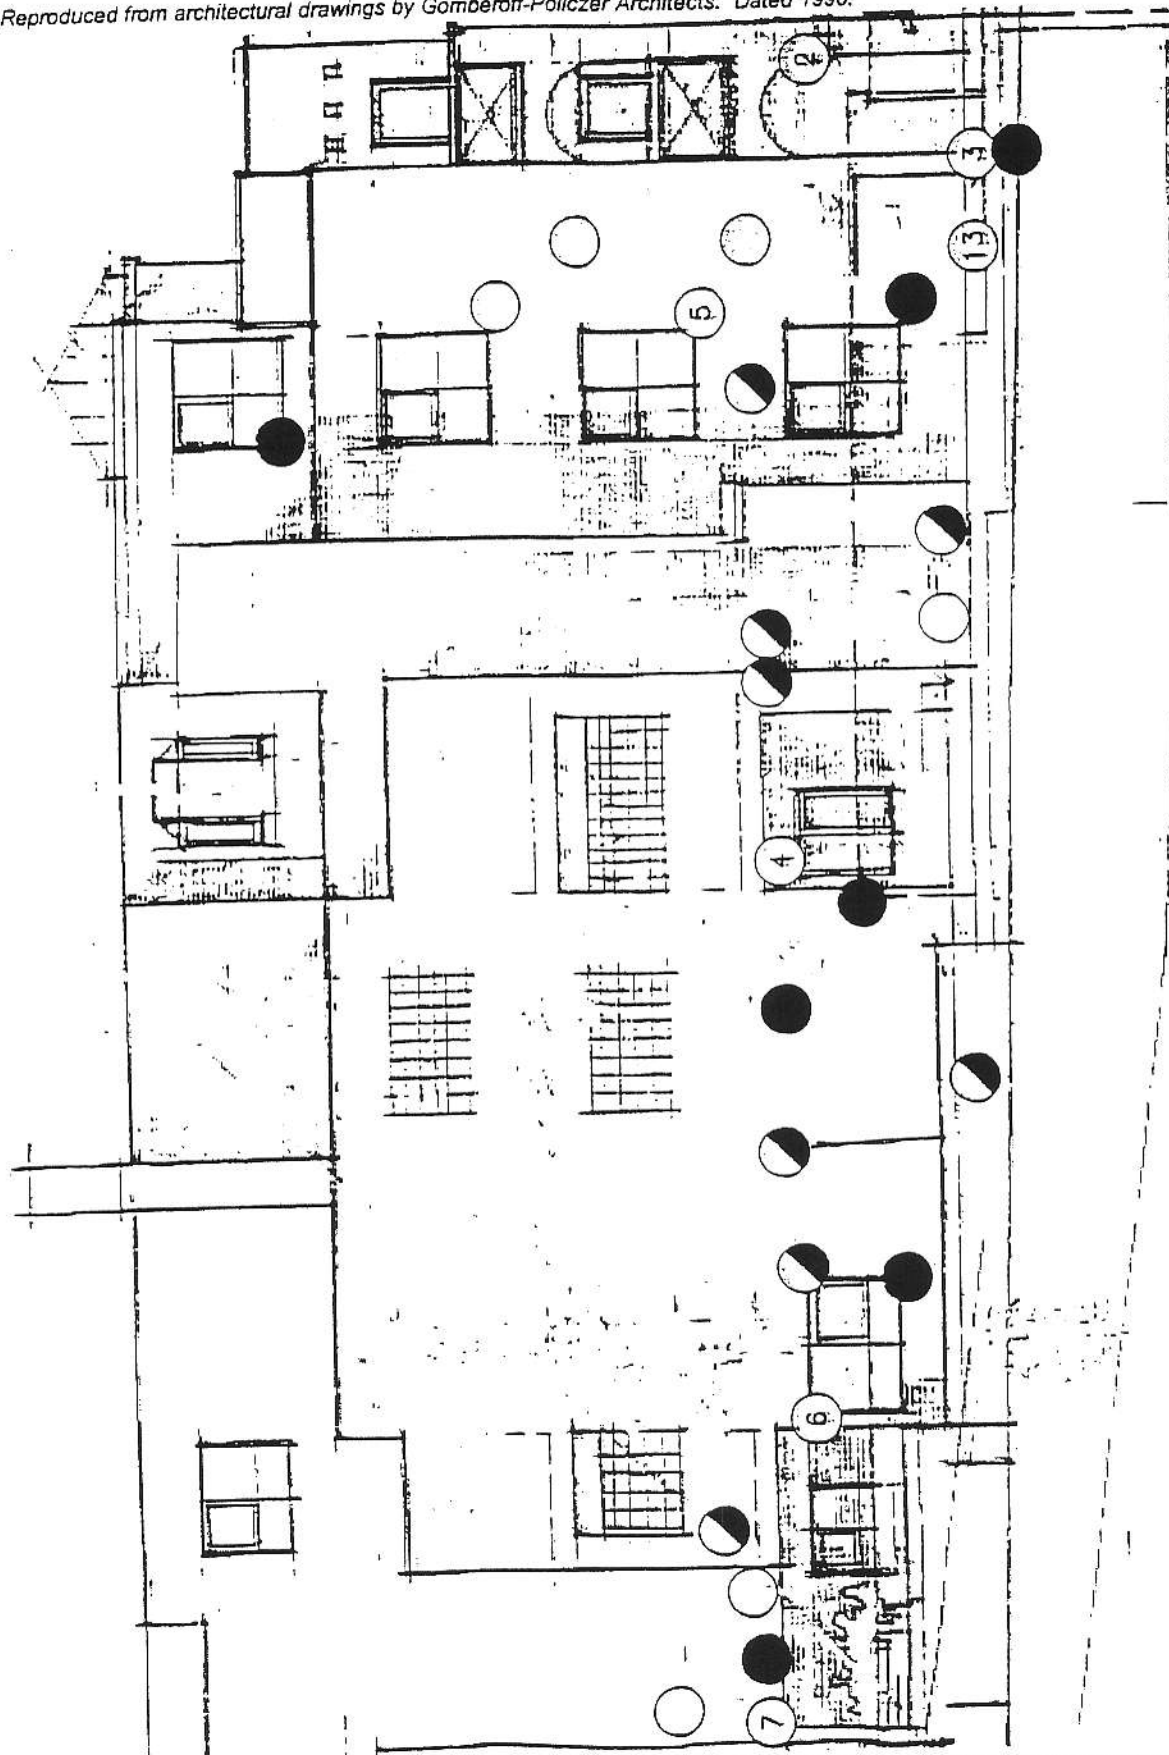
## EAST ELEVATION

T5 (10)	East Elevation – Unit 204 living room window sill	Removed stucco cladding and building paper; building paper liners installed at jambs and sill; field paper lapped over sill flange; wall sheathing decayed at sill jamb intersection only. Removed wall sheathing; framing decayed.
T6 (11)	East Elevation – Unit 102 master bedroom window head	Removed stucco cladding and housewrap; building paper liner; stucco thickness over 19mm; housewrap lapped over head flashing (~12mm lap); flashing upturn leg 38mm; window header decayed; wall sheathing at jamb decayed.
T7 (12, 13)	East Elevation – Unit 203 balcony soffit	Removed perforated metal soffit; stains on underside of soffit; staining and slight decay of parallam beam at end and at column connection; joists stained at end.
T8 (14)	North Elevation – Unit 304 unit 305 balcony saddle	Removed stucco cladding and building paper; sheathing dry; slight staining at saddle corner.

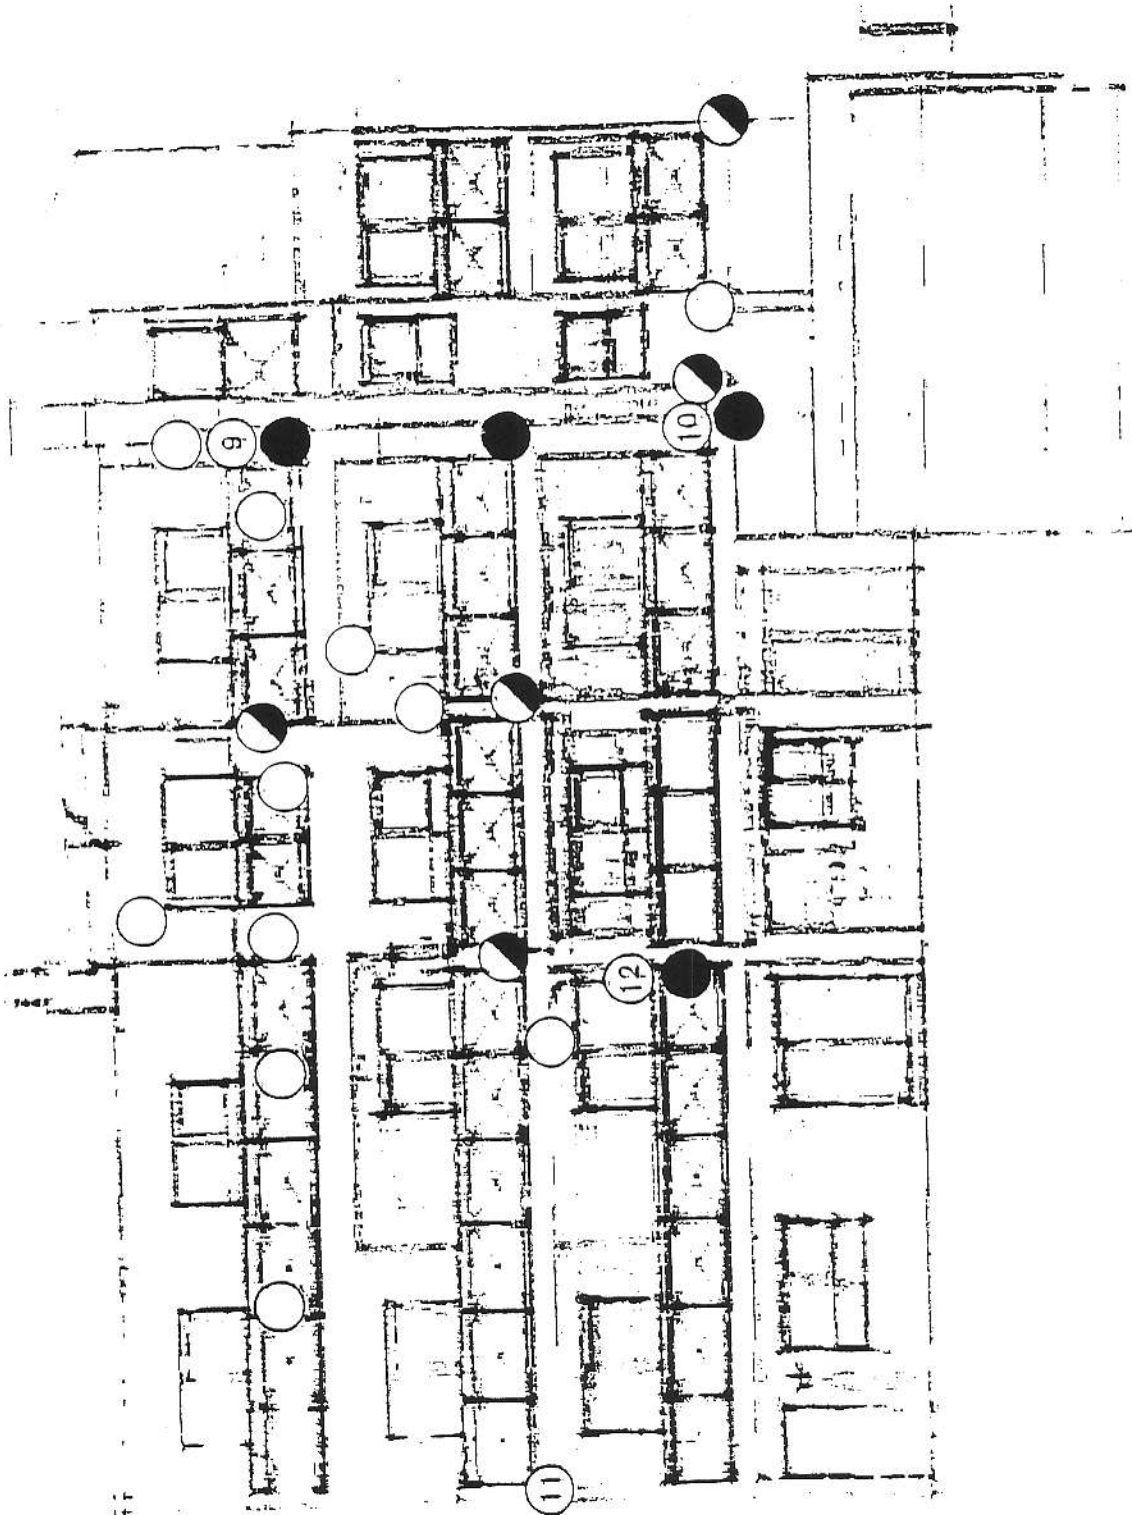
## SOUTH ELEVATION

T9 (15)	South Elevation – Unit 402 east parapet at roof deck	Removed stucco cladding and building paper; building paper slightly deteriorated with rust at fasteners; wall sheathing decayed. Removed wall sheathing; framing decayed, dry; adjacent wall framing decayed, dry.
T10 (16)	South Elevation – Unit 202 balcony at base of east column built out	Removed stucco cladding and building paper; balcony waterproofing 100mm onto wall; stucco stop 50mm from balcony surface; wall sheathing dry.
T11 (17, 18)	South Elevation – Unit 301 balcony beam at firewall	Removed stucco cladding and building paper; stucco lath rusted; building paper slightly deteriorated; wall sheathing decayed; balcony sheathing decayed. Removed wall sheathing; parallam beam and adjacent framing decayed; rust on saddle connection.
T12 (19, 20)	South Elevation – Unit 202 enclosed balcony	Removed stucco cladding and housewrap; wall sheathing decayed, with 25% to saturated MC. Removed wall sheathing; new studs present; framing behind decayed with 30% MC.
